DOT/FAA/AR-99/8,IV

Improved Barriers to Turbine Engine Fragments: Interim Report IV

June 2002

Interim Report

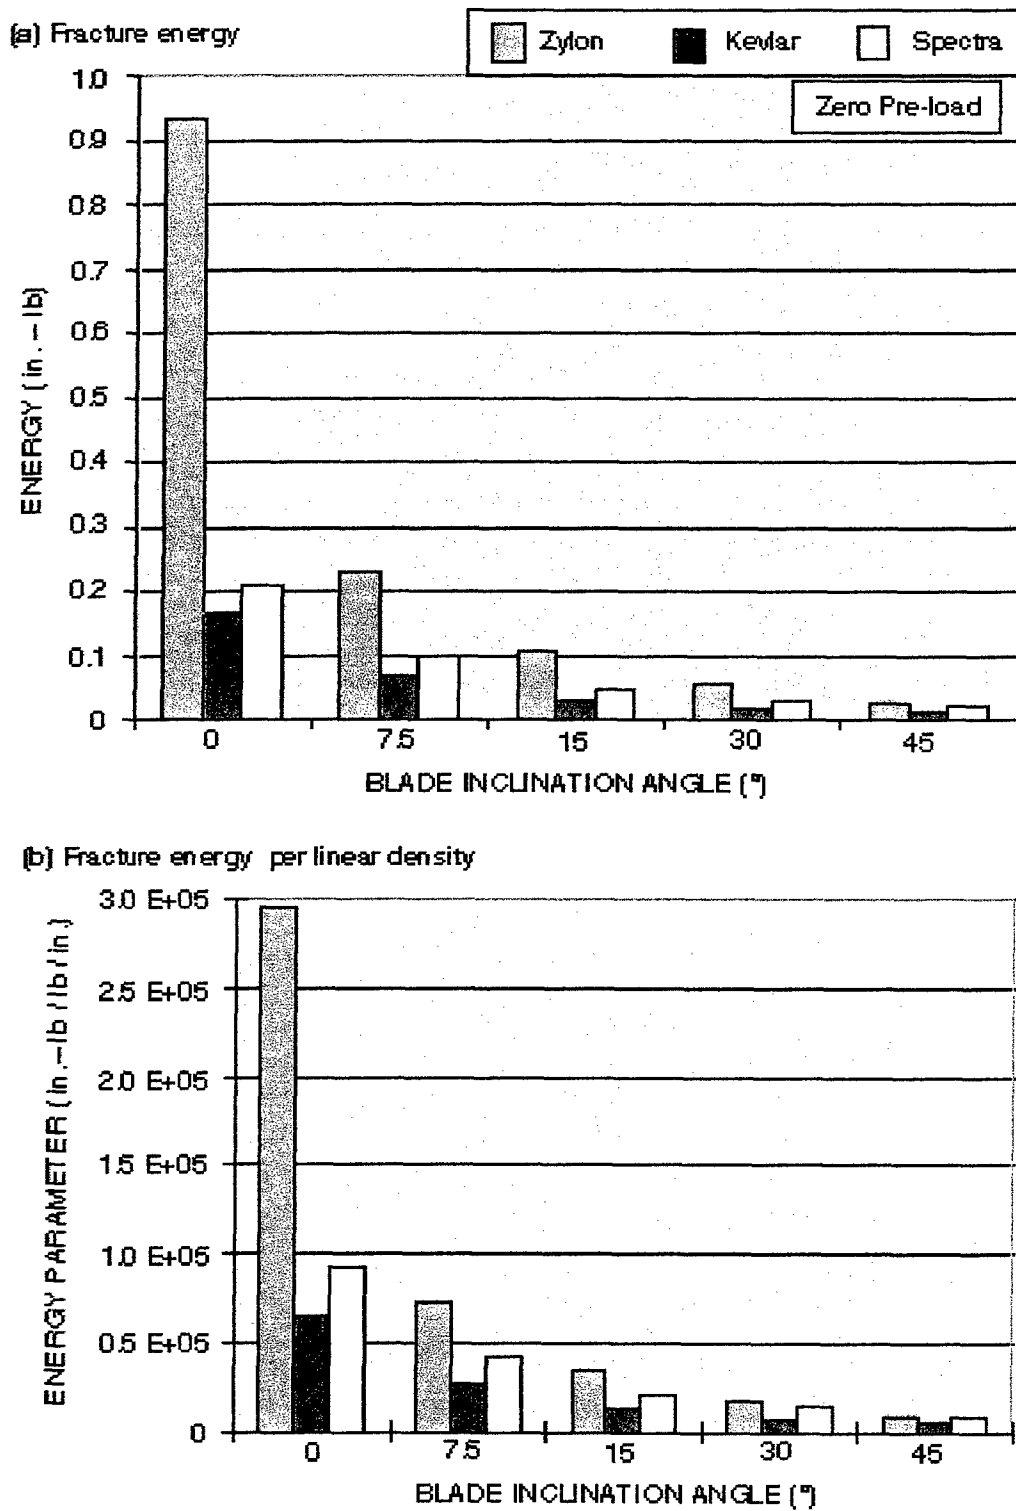
FIGURE A-7. DEPENDENCE OF FRACTURE ENERGY ON BLADE INCLINATION ANGLE FOR TRANSVERSE CUT TESTS WITH UTILITY BLADE

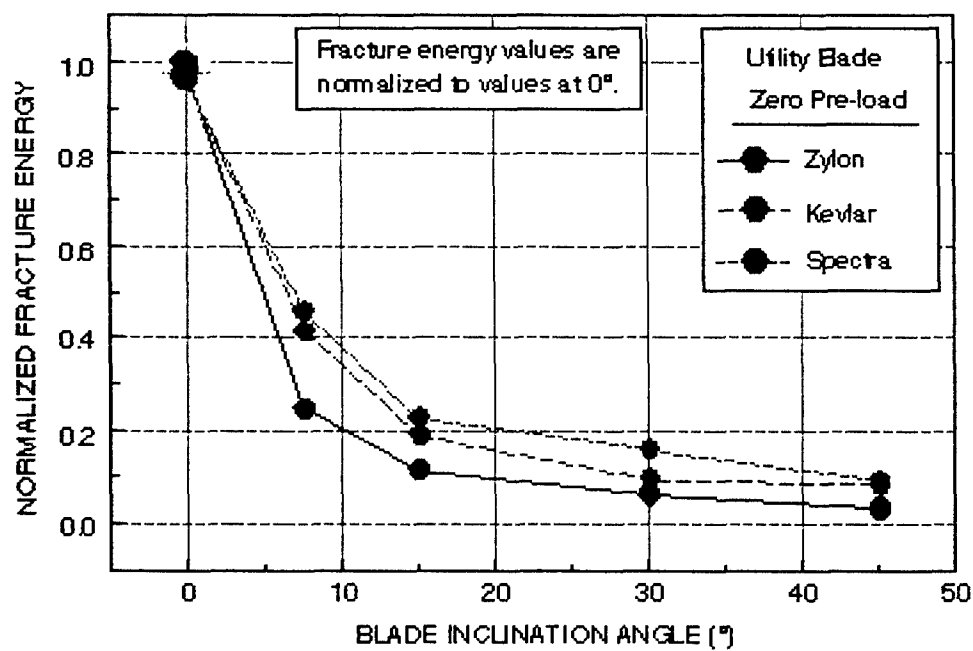
FIGURE A-8. DEPENDENCE OF FRACTURE ENERGY UPON ANGLE OF BLADE INCLINATION IN THE TRANSVERSE CUT TESTS

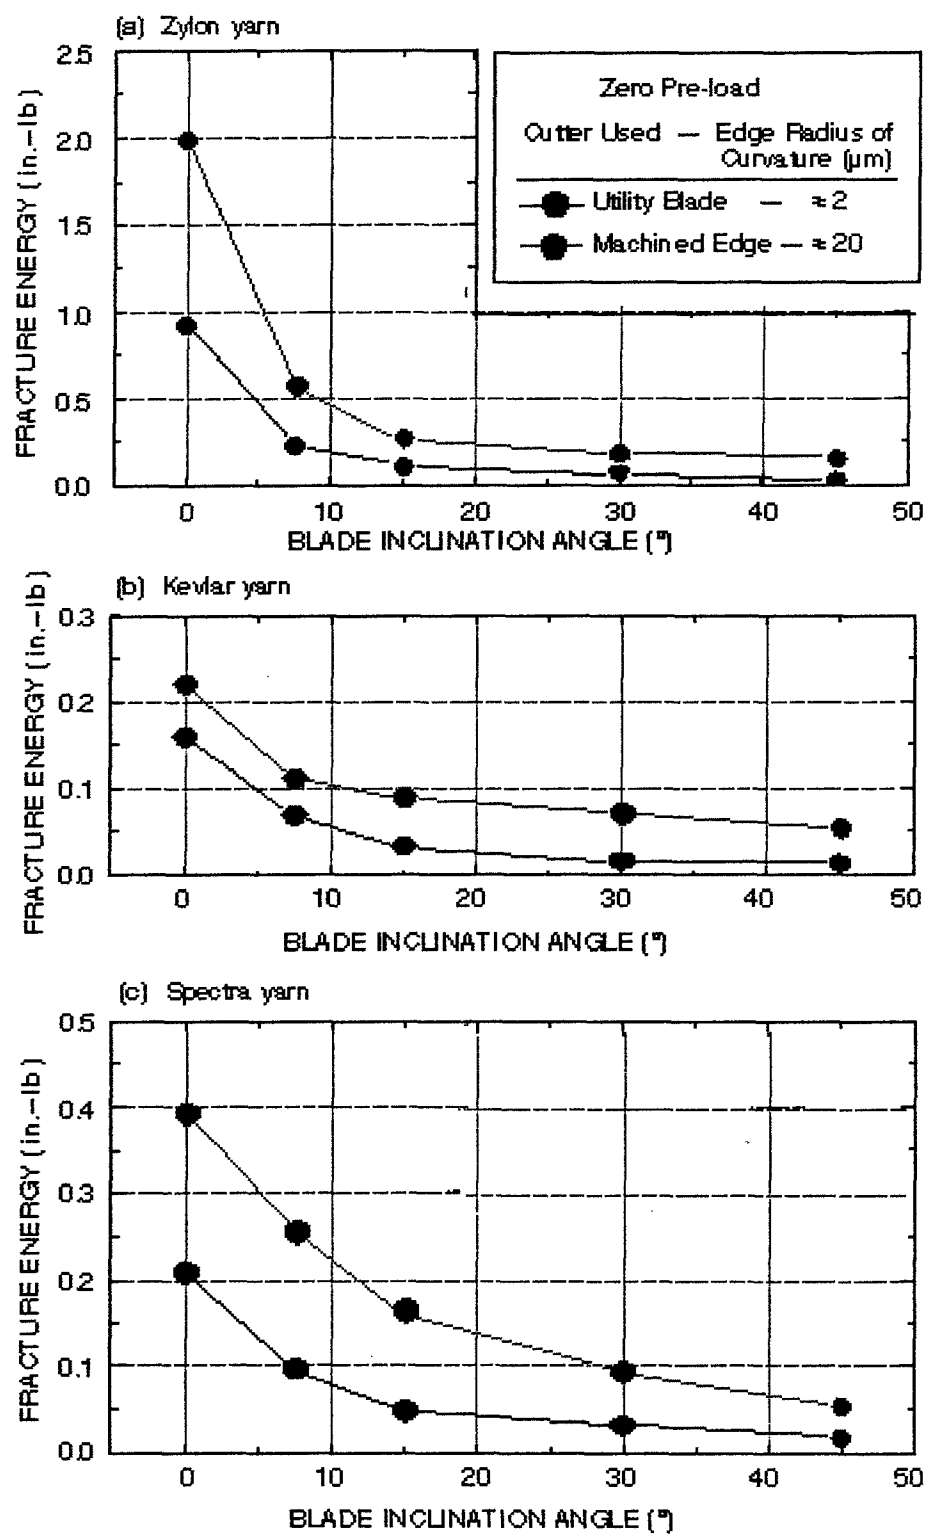
FIGURE A-11. EFFECT OF CUTTER SHARPNESS ON FRACTURE ENERGY IN TRANSFER CUT TESTS

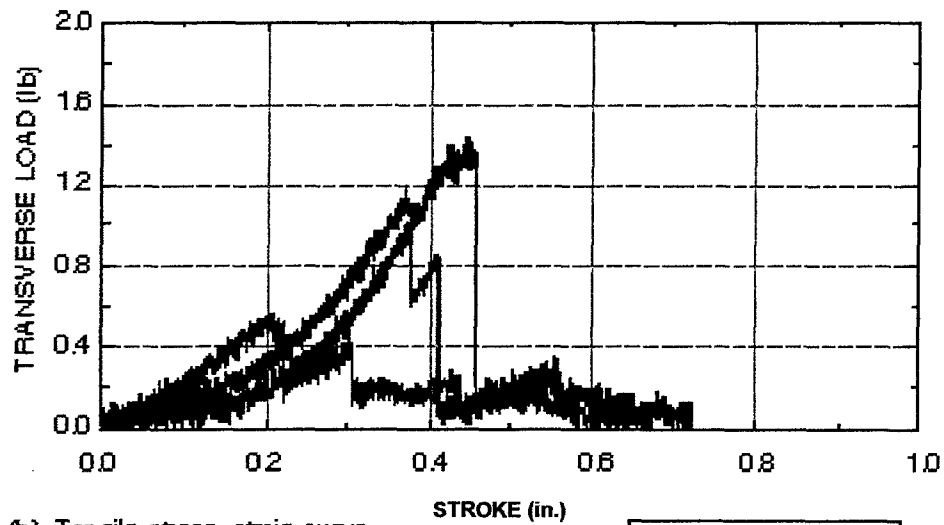
FIGURE A-12. EFFECT OF AXIAL PRE-TENSION ON TRANSVERSE CUT TEST BEHAVIOR OF ZYLON YARNS

(a) Transverse load-stroke curve

In a fragment impact scenario, some plies in a fabric barrier (particularly plies toward the back of a multi-ply barrier) might be stretched and under significant tensile loads before the edge of a sharp fragment makes first contact. Therefore, it is important to understand how the cut resistance of a fabric might be affected by a tensile pre-load. Figures A-12 through A-14 show the effect of axial pre-tension on the yarn behavior during transverse cut tests. For each of the three materials, results of a test with the utility blade at a 0° inclination angle and no pre-load are compared with two similar tests with pre-loads that vary from 1 to 5 lb. As expected, pre-tension produced a shift in the transverse load-stroke toward lower stroke and load and an earlier fiber breakage initiation. Figure A-15 shows the decrease in the fracture energy for these tests as the pre-load increases.

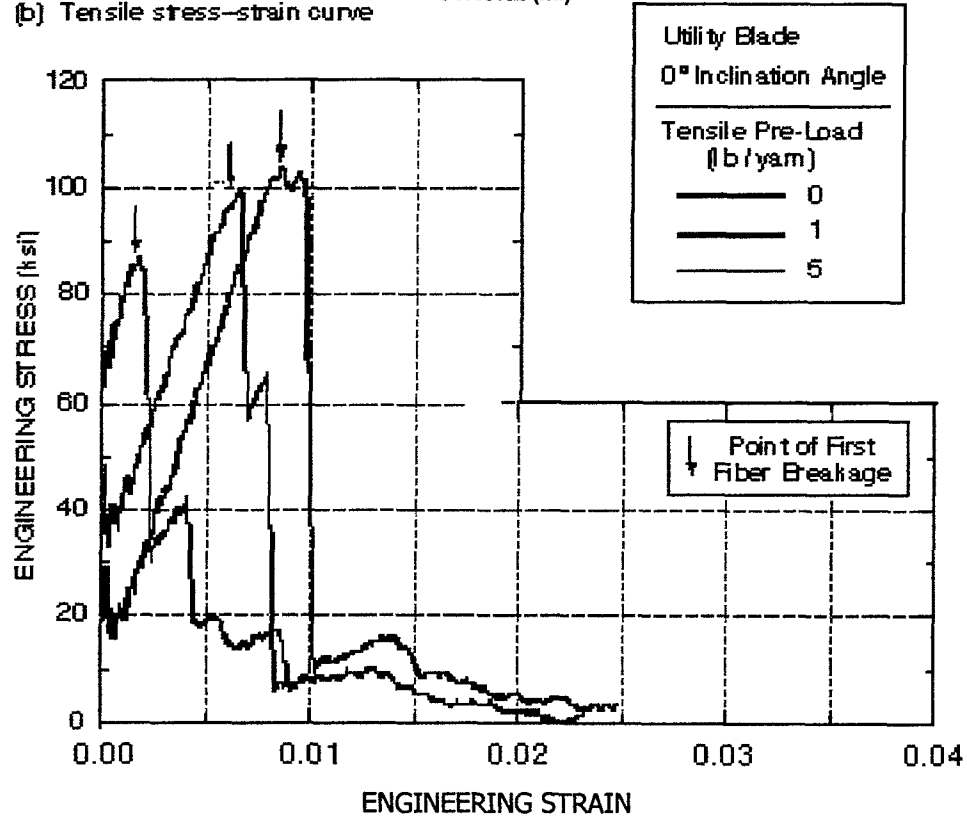
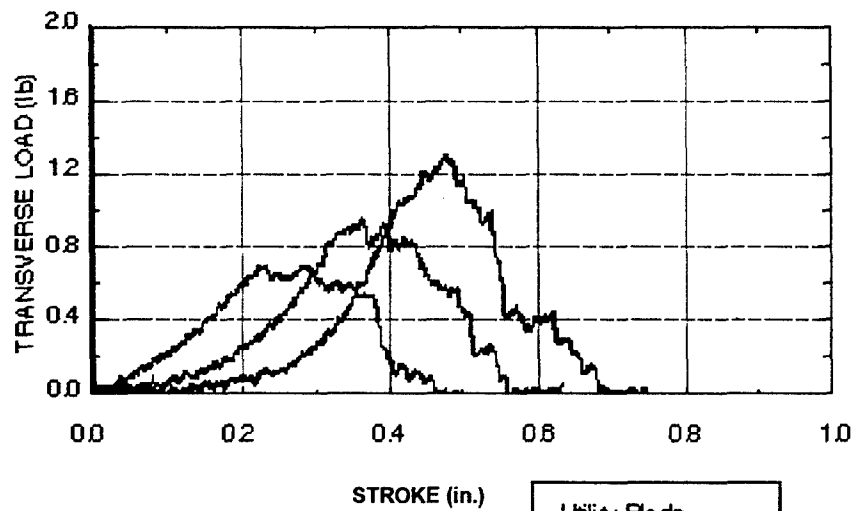
FIGURE A-13. EFFECT OF AXIAL PRE-TENSION ON TRANSVERSE CUT TEST BEHAVIOR OF KEVLAR YARNS

(a) Transverse load-stroke curve

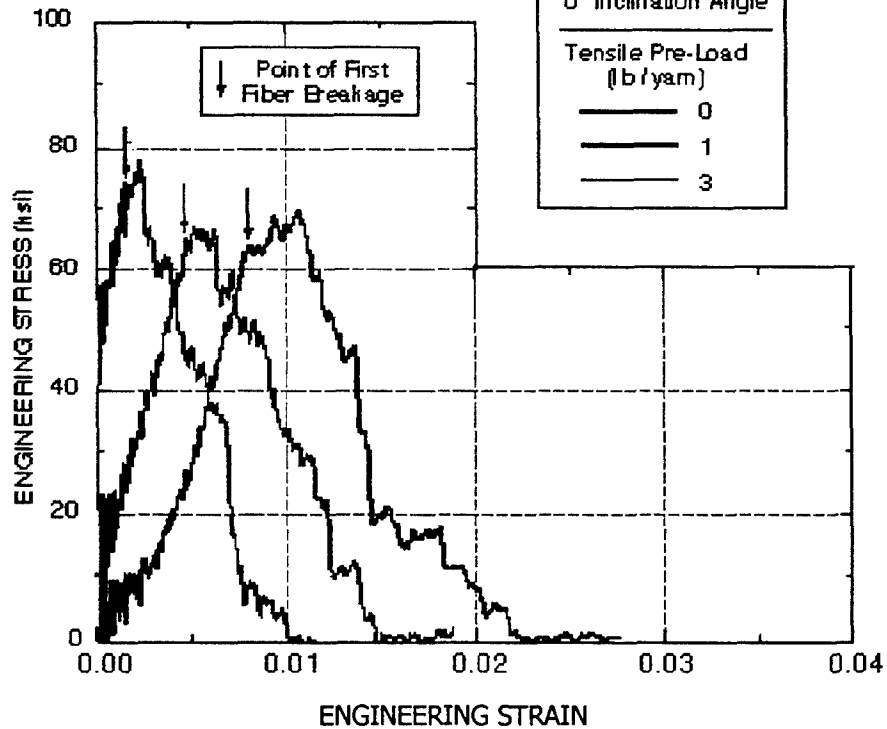
FIGURE A-14. EFFECT OF AXIAL PRE-TENSION ON TRANSVERSE CUT TEST BEHAVIOR OF SPECTRA YARNS

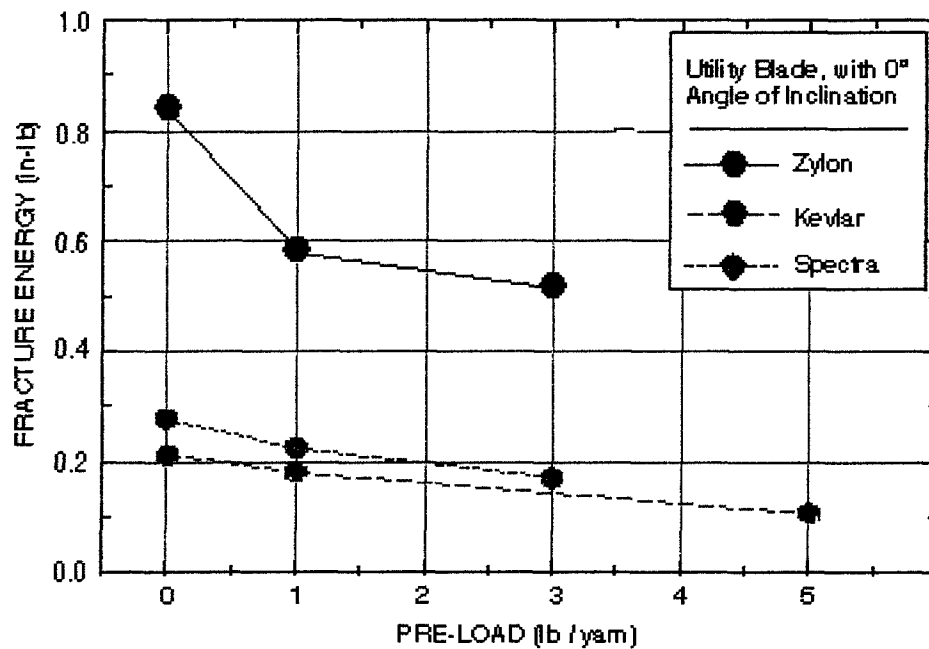
FIGURE A-15. DEPENDENCE OF FRACTURE ENERGY UPON TENSILE PRE-LOAD IN THE TRANSVERSE CUT TESTS
